TDD# F5-8103-11

HOOVER B+B / WASHTENAW Co.
(SALINE DIE CASTING)

SECTION III - ON-SITE INSPECTION/SAMPLING

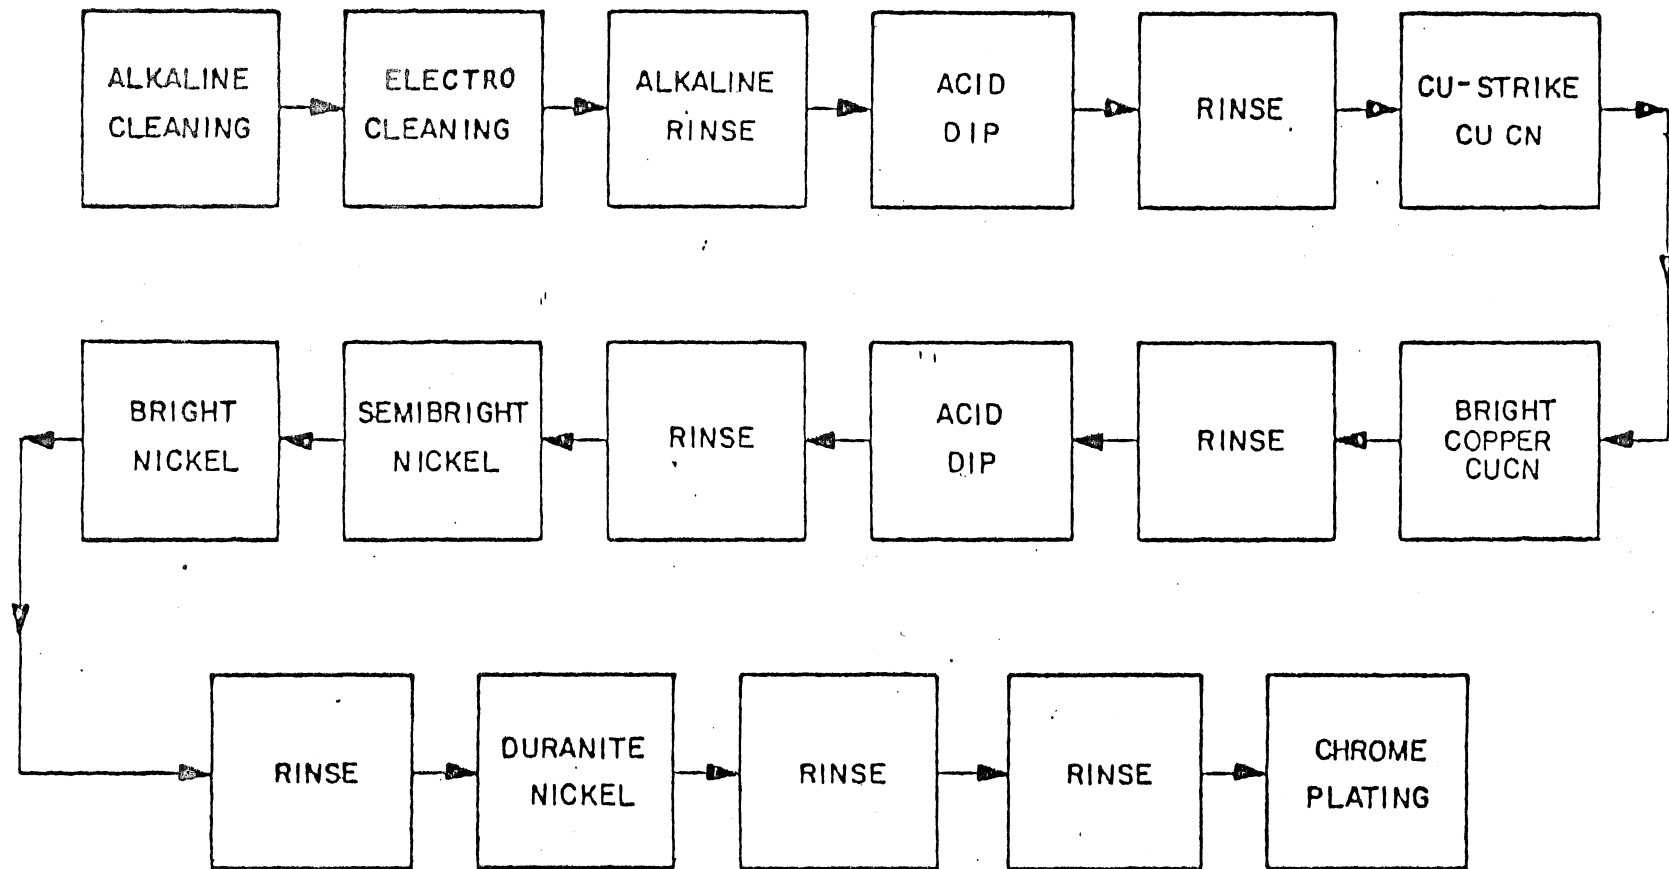
Figure 3. Electroplating Process Block Diagram

Several different types of waste are treated by the plant. These wastes include rinse water from the plating and replating operation, cooling water from two air compressors, and backflush water from the deionizers. Most of the plants wastewater comes directly from the plating and replating lines (see Figure 4).
